**DRAFT REPORT
ROUND 7 DAM ASSESSMENT
ALLETE, INC. - LASKIN ENERGY CENTER
CELLS A-D AND CELL E IMPOUNDMENTS**

November 18, 2010

Re: Round 7 Dam Assessment - Draft Report
EPA Contract No. EP10W001313
Allete Inc. Laskin Energy Center
Cells A-D Impoundment and Cell E Impoundment
Hoyts Lake, Minnesota

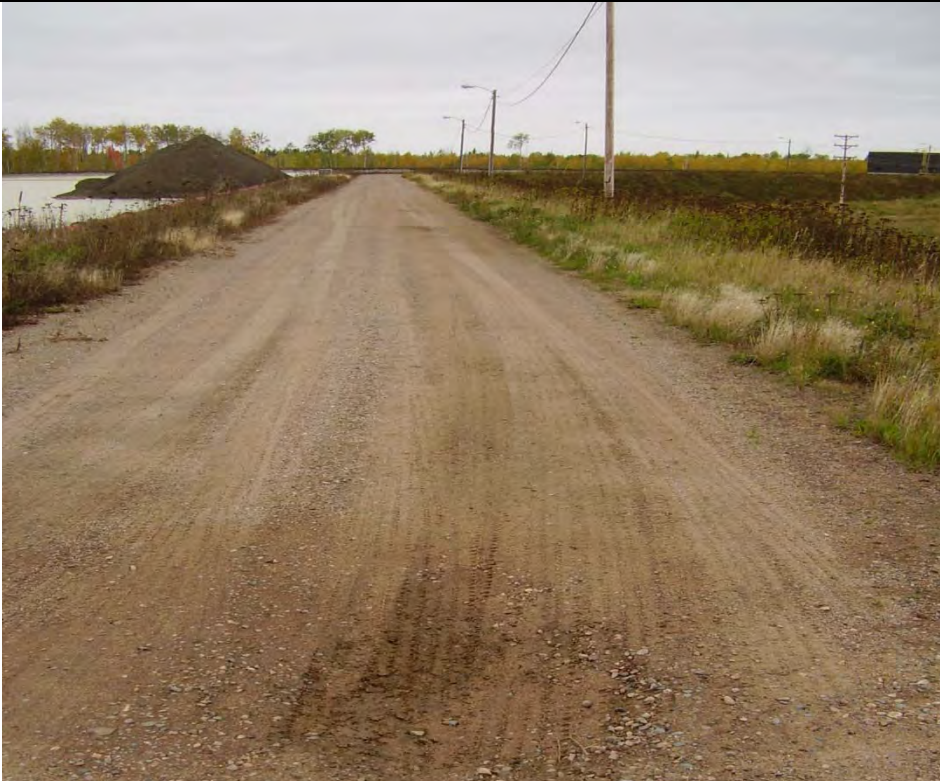
The top of the Cell E Impoundment had a gravel cover, with some grasses. The top of impoundment had occasional minor pot holes along the entire length from vehicular traffic. The alignment of the top of impoundment appeared generally level, with no depressions or irregularities observed. Based on information provided by Barr, the top of impoundment elevation ranged from elevation 1479 feet to elevation 1483 feet MSL. No significant settlement was observed at the time of our inspection. There was approximately 3 feet of free board at the time of our inspection.

Direction Photo Taken: South			
Description: Example of potholes in top of embankment in Cell E.

1. Increased mowing of the grasses on the embankments to facilitate daily inspections and reduce the risk of burrowing animals;
2. Repair the potholes present in the gravel crest access road. Grade the road to provide better drainage and reduce future potholing;
3. Clear deep rooted vegetation from embankments and top of impoundments;
4. Document impoundment inspections conducted by facility personnel each shift; and,
5. Extend monitoring, maintenance and emergency action plans to include the Cells A-D Impoundment.

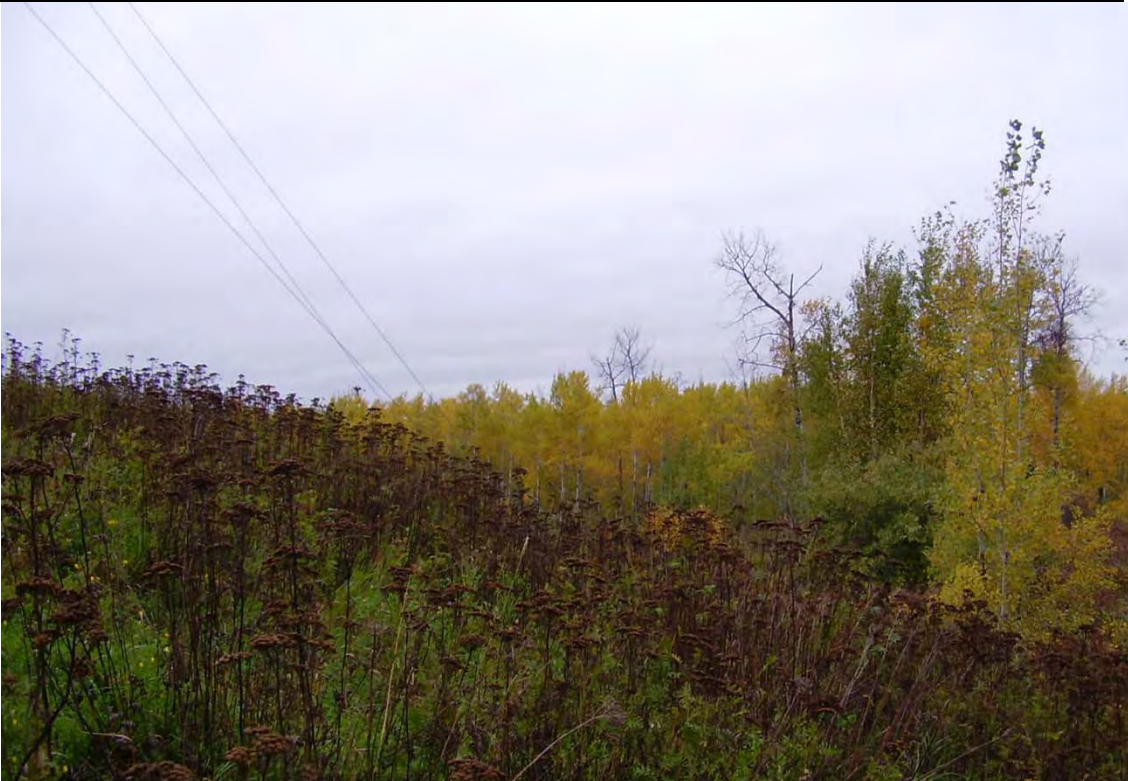
Client Name: U.S. EPA		Site Location: Laskin Energy Center Hoyt Lakes, MN	Project No. 01.0170142.20
Photo No. 27	Date: 9/23/10

Direction Photo Taken: Southwest			
Description: Downstream slope and toe of Cell E. Trees growing on the slope are shown on right of photo.

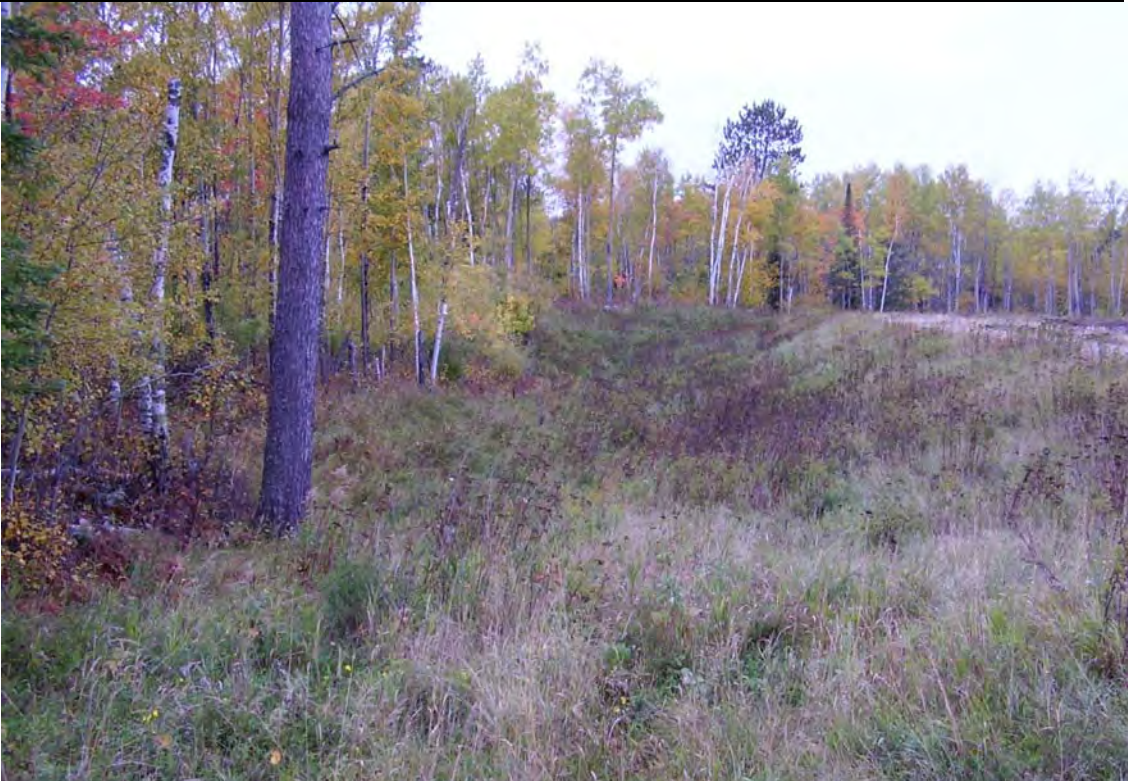
The downstream slope of the impoundment was generally in good condition. The surface cover of the slope was grassed but had not been recently mowed. A minor erosion rill was observed along the toe of the eastern embankment as shown in Photo No. 34 and Photo No. 35. The rill was noted in the 2009 and 2010 inspections completed by Barr as being vegetated and apparently stable. Two 2-inch diameter trees/shrubs were observed on the toe at the northwest corner of the impoundment as shown in Photo No. 27. No unusual movement or sloughing was observed in the slope. A gravel access road was present along the toe of the downstream slope on the northern portion of the impoundment. The access road was in good condition, with minor rutting on the surface. No seepage or sloughing was observed on the downstream slope.

Direction Photo Taken: South			
Description: Erosion feature on toe of east slope that has been overgrown with grass.
